R-85 Phonograph Record Changer Mechanism Adjustmemt

SERVICE BUILDETIN Phonograph Newsletter

VERNIER OPTICAL SWITCH

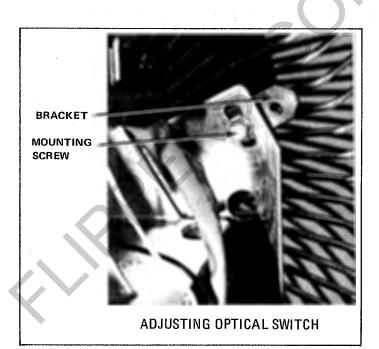
It has been found that improper adjustment of the Optical Switch on Model 8700 Record Changer Mechanisms results in erroneous play (e.g., if selection 160 is made, record 159 or 161 will play instead).

To improve accuracy of Optical Switch Adjustment, a revised method is hereby outlined:

- 1. Release Magazine Sprag Lever from Sprag Wheel and rotate Record Magazine until selection 99 is at top center. Engage the Sprag Lever, locking the magazine in place.
- 2. Loosen Optical Switch Bracket Mounting Screw and move bracket to the most downward (clockwise) position.
- 3. Rotate Record Magazine counter-clockwise to remove gear backlash *bold in this position.*

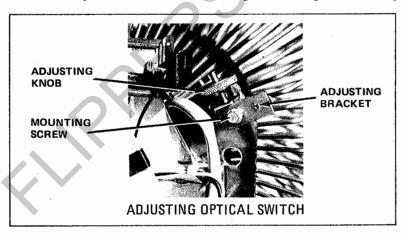
A vernier Optical Switch adjustment has been added to the R-85 Phonograph Record Changer Mechanism starting with mechanism serial no. 068967. The vernier provides a more accurate Optical Switch adjustment when record magazine realignment is required.

A kit is available for mechanism update. Order from Rowe, Grand Rapids, as follows:
