## WURLITZER

Dollar Bill Accepter Double Pulser Modification.

## WIRING DIAGRAM SUPPLEMENT 3400A Series Phonograph (With Dollar Bill Accepter)

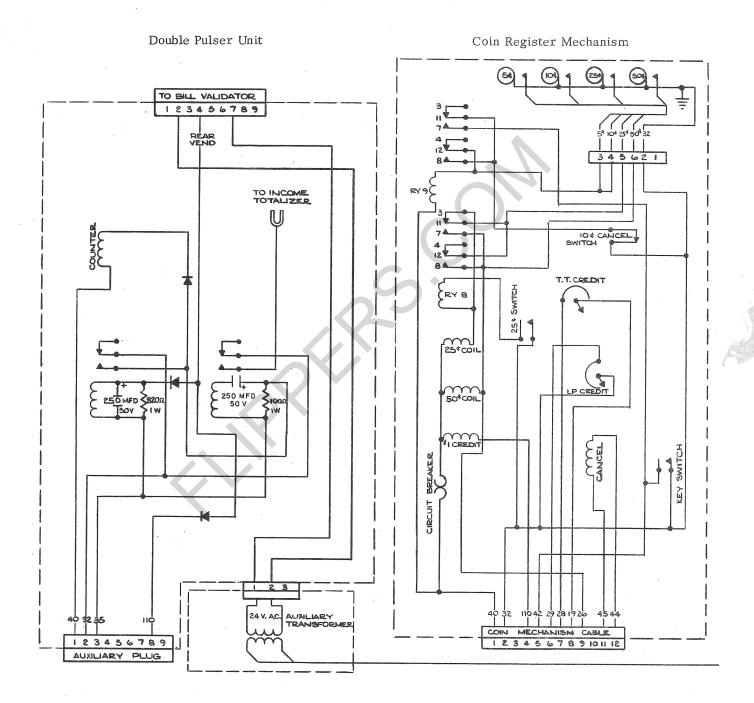
Circuit Breaker being tripped by too long a pulse when validating

a dollar bill.

- 1. Verify continuity between lug 4 of 5 lug terminal strip (3, Figure 1) and Pin 8 of Computer Plug. If continuity can not be established transpose the Orange wires connected to lugs 3 and 4 of 5 lug terminal strip. Repeat continuity check.

- 2. Cut lead of Diode (1, Figure 1) as close to relay terminal connection as possible and connect this lead to Lug 2 of 3 Lug Terminal Strip as shown in Figure 2. Do not solder at this time.

- 3. Remove Black wire with Orange tracer (2, Figure 1) from coil terminal of left hand relay (DO NOT remove Purple wire).
- 4. Connect Black wire with Orange tracer, removed in Step 2, to Lug 2 of 3 Lug Terminal Strip as shown in Figure 2. Do not solder at this time.

- 5. Install Sleeving on Diode leads and connect Band or Cathode Lead to coil terminal of left hand relay as shown in Figure 2. Solder this connection.

- 6. Connect remaining Diode lead to Lug 2 of 3 Lug Terminal Strip as shown in Figure 2. At this time there should be the 2 Diode leads and the Black wire with Orange tracer connected to Lug 2 of 3 Lug Terminal Strip as shown in Figure 2. Solder these connections securely.
