SERVICE SLANTS

ISSUED BY WURLITZER SERVICE DEPT., NORTH TONAWANDA, N. Y.

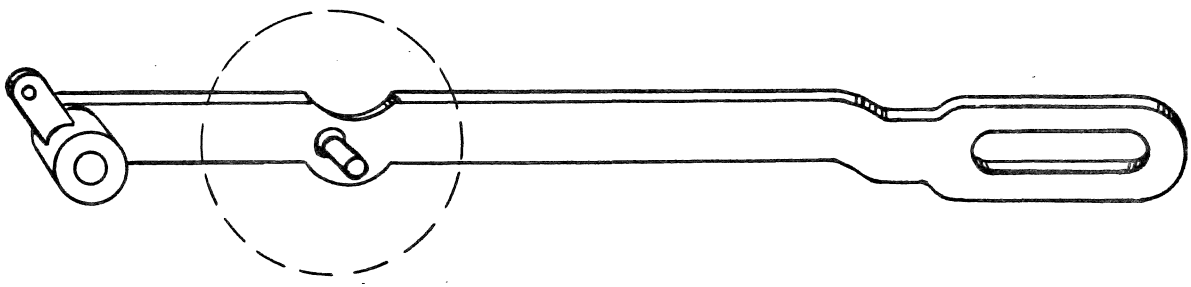
In making a field survey of the new Model 1015, we have found cases where the rivet on the actuating lever, shown above, is not tight.

This condition has now been corrected but all phonographs previously received should be checked for this particular trouble. When this rivet becomes loose, it will cause the following troubles:

1. Rotary arm pin jamming on the star wheel.
2. Take out block pulling out 2 trays at one time.
3. Repeating selections without depositing coins.
