# SERVICE SLANTS

ISSUED BY WURLITZER SERVICE DEPT., NORTH TONAWANDA, N. Y.

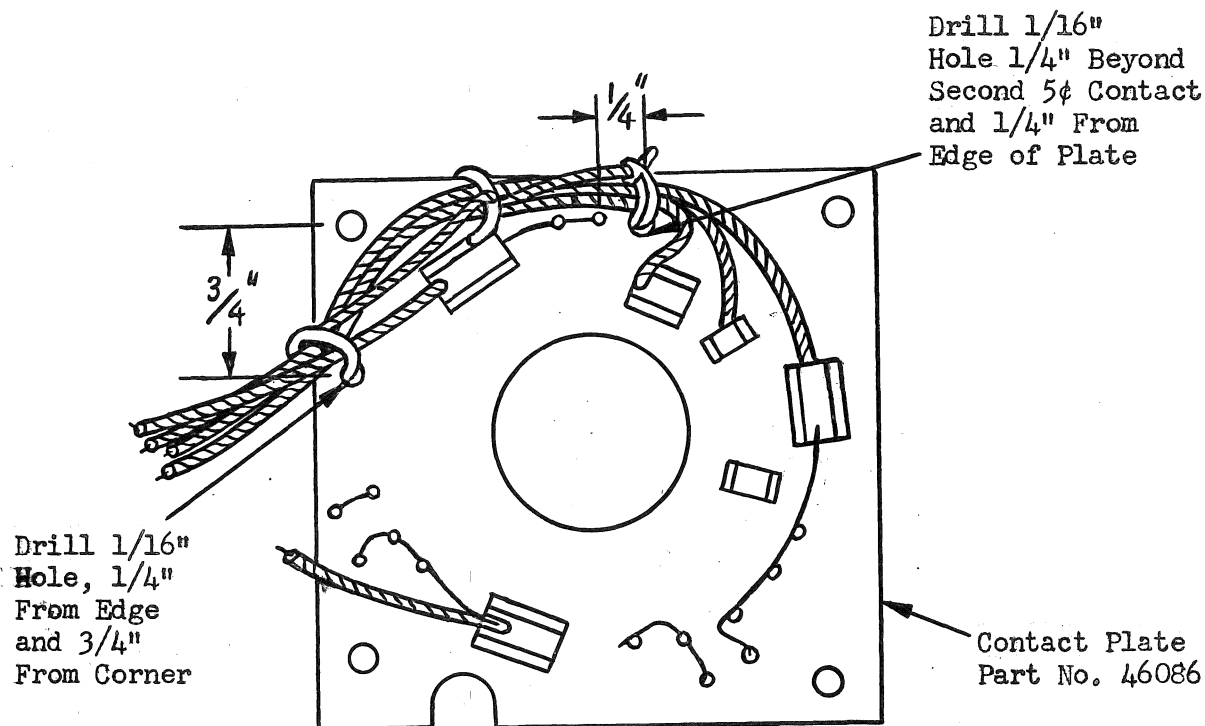
In early Model 3020 Wall Boxes, connecting wires to the contacts on the No. 46086 contact plate were anchored to the plate with cellulose tape. Occasional cases would arise where the tape would work loose, allowing the wires to become entangled with the follower roller on the No. 45870 follower arm. The follower arm would then fail to return to its normal position and would hold back the No. 45786 cancel pawl so that further cancellation of plays on the accumulator would stop, resulting in "free plays".

This condition has been corrected by eliminating the use of cellulose tape and by tying back the wires with cord. Drawing below shows how this is done in current production; this method may be used in the field to correct "free plays" which arise as a result of this condition.

Anchor wires by passing cord through the holes as shown and tying around edge of plate. Comparison with a later Model 3020 Wall Box will illustrate the method clearly.
