# SERVICE SLANTS

ISSUED BY WURLITZER SERVICE DEPT., NORTH TONAWANDA, N. Y.

November 8, 1947

SUBJECT: PART NO. 45617 RELAY FOR MODEL 216 IMPULSE RECEIVER.

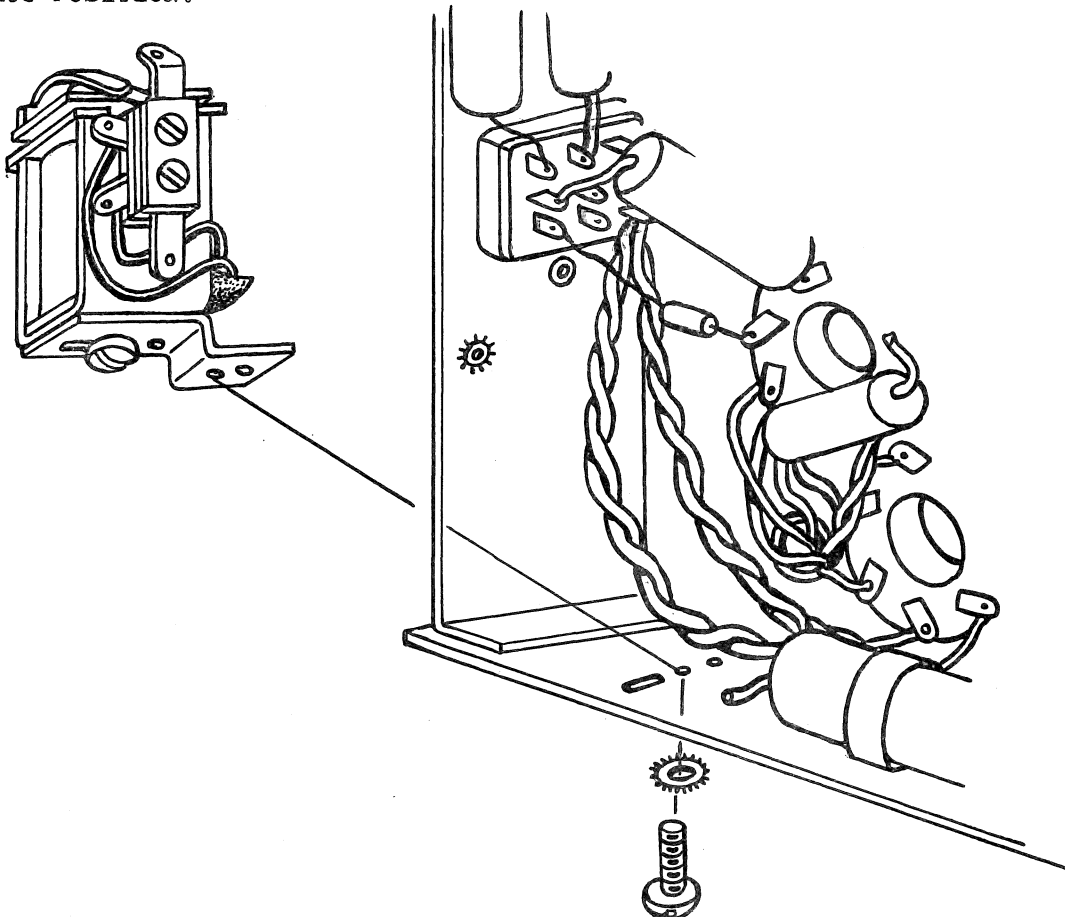
Part No. 45617 Relay has been obsoleted and is no longer available. Part No. 48833 Relay has been substituted in production, and will be shipped in place of the obsoleted item in all parts orders as Part No. 48833.

Part No. 48833 Relay is supplied mounted to a bracket. If used to replace a relay of the same type in a later Model 216 Receiver, the bracket is removed and the relay installed in the same manner as the original relay.

In early Model 216 Impulse Receivers, the method of installing Part No. 48833 Relay is illustrated below. NOTE THAT MOUNTING BRACKET IS SHOWN IN CORRECT POSITION.
