SERVICE SLANTS

ISSUED BY WURLITZER SERVICE DEPT. NORTH TONAWANDA, N. Y.

MODEL 1100 ENCORE SELECTOR MOTOR

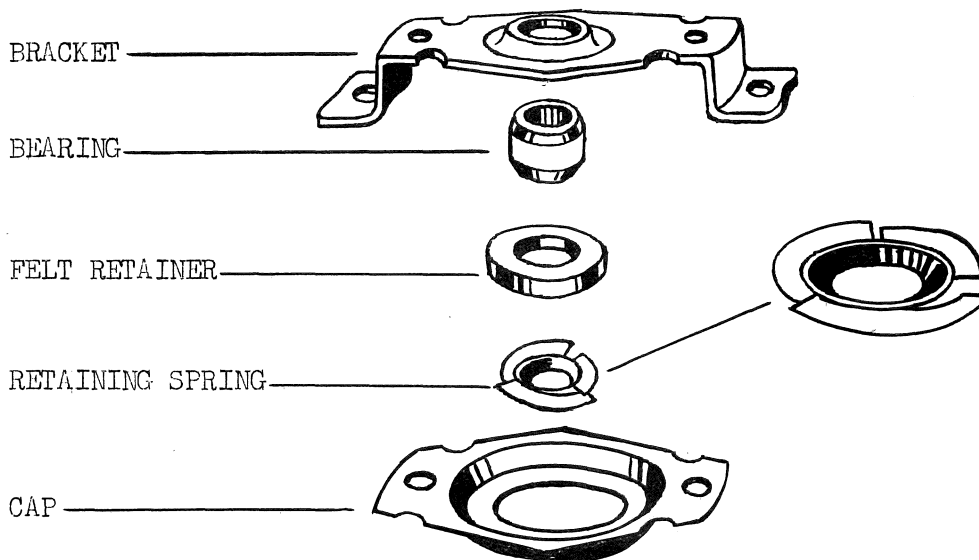
The armature rubbing the pole piece indicates possibility of worn bearing. However, drilling out rivets of the bearing bracket reveals that only the tension of the retaining spring has collapsed. It is stated this lateral freedom allows the bearing to turn with the shaft.

By raising the three ears of the retaining spring, the tension is restored, and when re-assembled, the motor is said to operate satisfactorily for an indefinite period.
