# SERVICE SLANTS

ISSUED BY WURLITZER SERVICE DEPT., NORTH TONAWANDA, N. Y.

## Installation of Back Stop Pawl

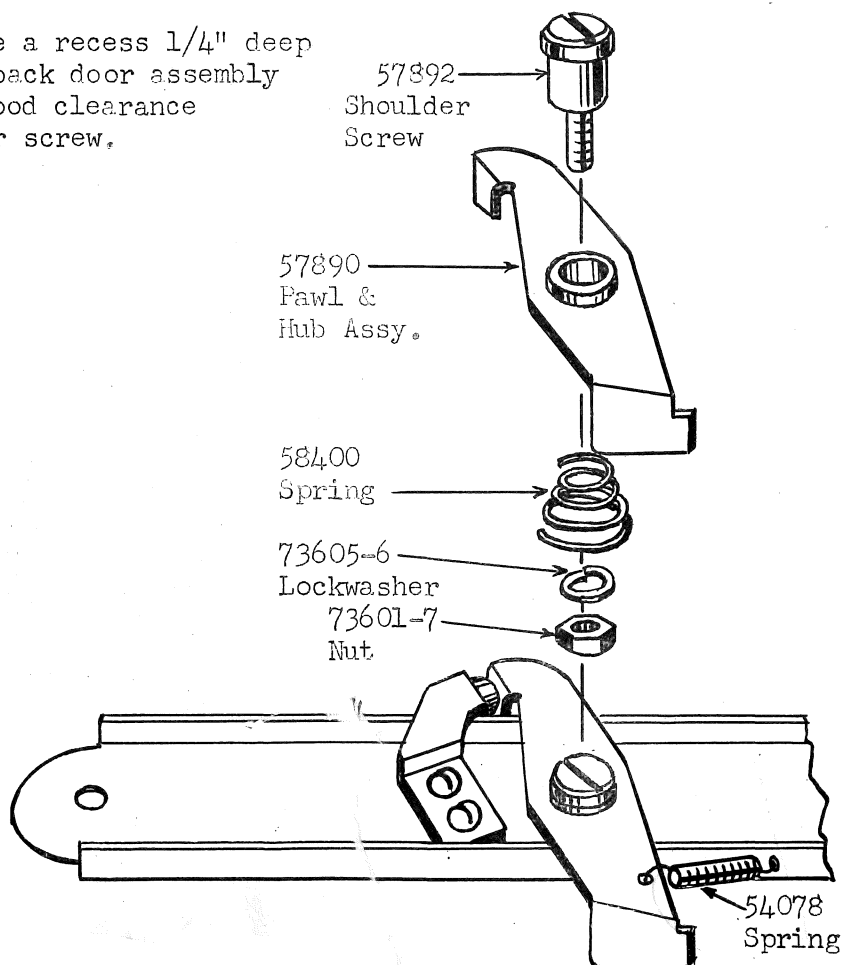
Where it is found desirable to replace #57651 Lever and Pin Assembly with #57890 Pawl and Hub Assembly, this may be accomplished by drilling one hole in the Channel and Bracket Support Assembly.

Drill hole .171" diameter (or #17 drill) on center line. This locates  $3/8$ " below and  $3/32$ " toward selector shaft from center of the hole used in mounting first back stop pawl. We are supplying a template to locate drilling point.

Remove old pawl. For convenience also remove the bracket and rubber bumper which will be used again after drilling hole.

Mount #57890 Pawl and Hub Assembly as indicated in sketch below. A Spring, #58400, is mounted with small section next to the pawl as indicated.

Counter-bore a recess  $1/4$ " deep in cabinet back door assembly to afford good clearance for shoulder screw.
