# SERVICE SLANTS

ISSUED BY WURLITZER SERVICE DEPT., NORTH TONAWANDA, N. Y.

## MODEL 1900

SUBJECT: To Tighten Driver Lever Mounting Stud.

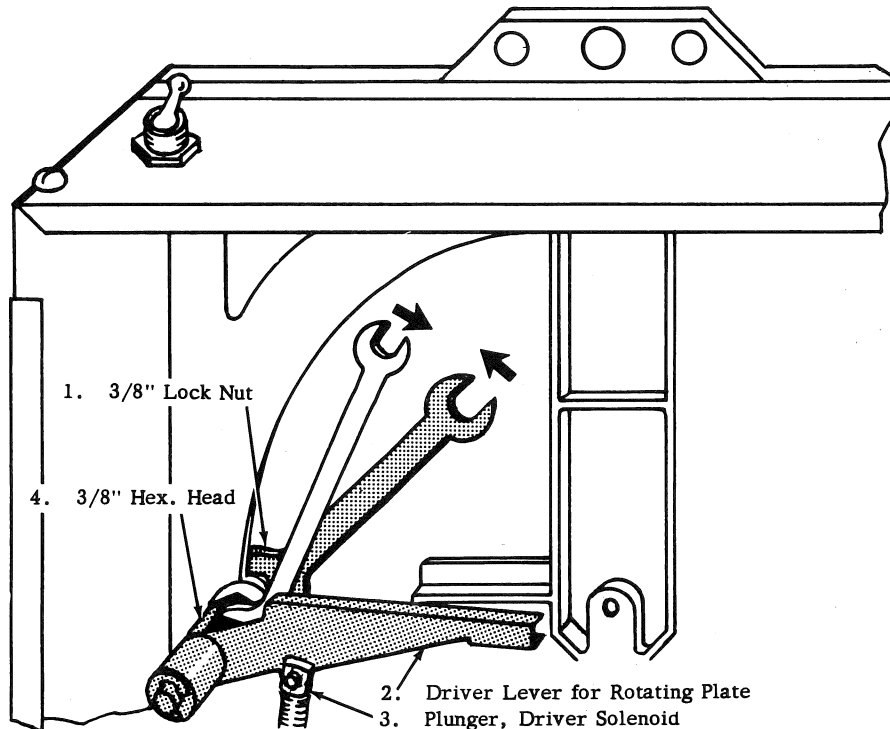
1. In cases where a wrong letter selection is experienced it may be found that the "Mounting Stud" for the "Driver Lever of the Rotating Plate" has loosened. As shown in sketch below, this stud may be tightened from underneath the selector by using one 3/8" open end wrench to tighten and hold the stud and a second 3/8" open end wrench to tighten the lock nut.
