SERVICE SLANTS

ISSUED BY WURLITZER SERVICE DEPT., NORTH TONAWANDA, N. Y.

SUBJECT: 2600 Series Phonographs - rumble in music. Appears as a definite beat with each revolution of the record. More noticeable when playing at 33 1/3 R. P. M.

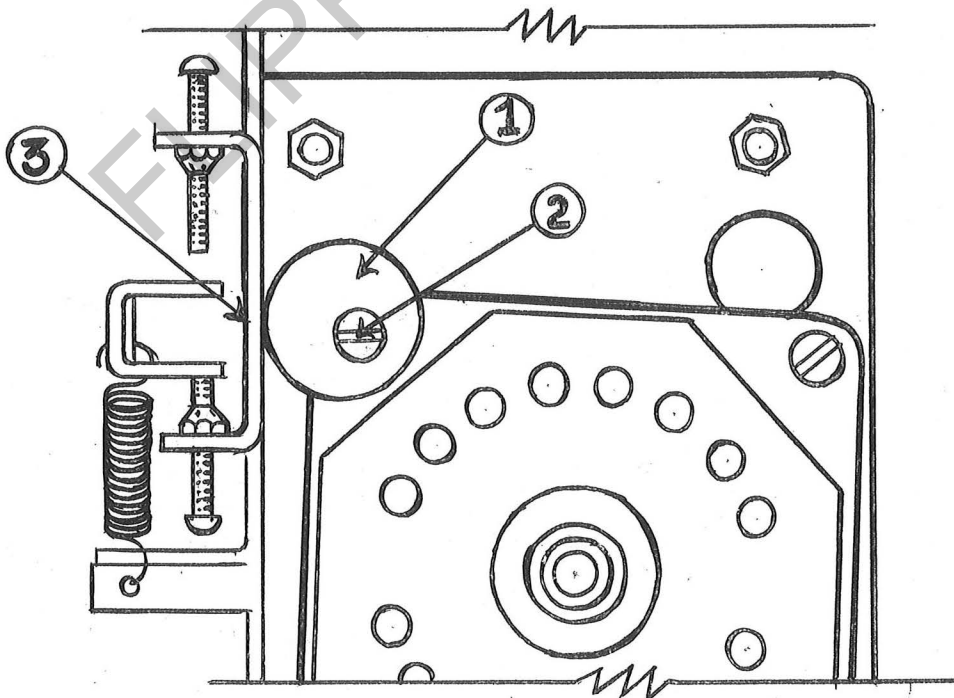
CAUSE: The frequency of some tones produced by certain records set up mechanical vibrations in turntable motor and mounting bracket.

CORRECTION: The Eccentric Washer, Part No. 122050, shown at Item 1 in the figure below, may be installed by removing the screw, Item 2. A longer replacement Screw, Part No. 36176, is furnished for installing the eccentric washer.

Insert the longer screw through the eccentric washer and install the screw through the motor laminations and into the motor mounting stud. Set the eccentric washer to bear firmly against the Shift Solenoid Mounting Bracket, Item 3. Hold the washer in this position and tighten the screw.

CAUTION: A microphonic condition may be produced if the eccentric washer is forced too tightly against the solenoid mounting bracket.
