# WURLITZER SERVICE SLANTS

- SUBJECT:** Model 3500-4 and 3500-7 Phonographs
- COMPLAINT:** Isolated instances of Selection Accumulator Motor running continuously when selecting LP or Preselected Program Selections, locking out Phonograph.

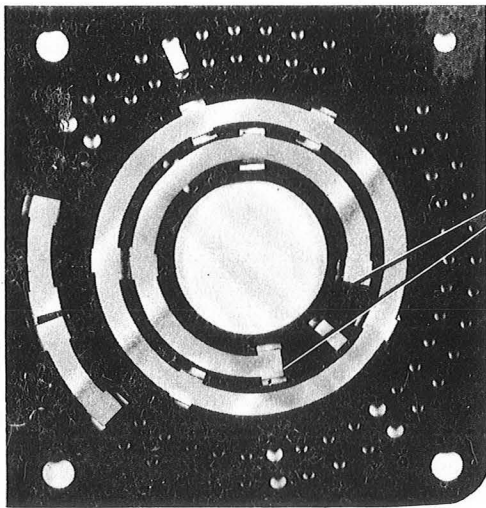
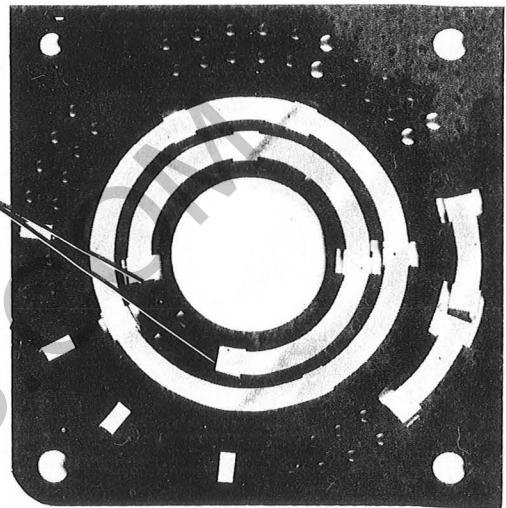
5. Examine Full Cycle Patches on both Cancel and Motor Contact Plate and Wire Assemblies and verify that both Full Cycle Patches are correctly trimmed as shown in Figure 1.

CORRECTLY  
TRIMMED

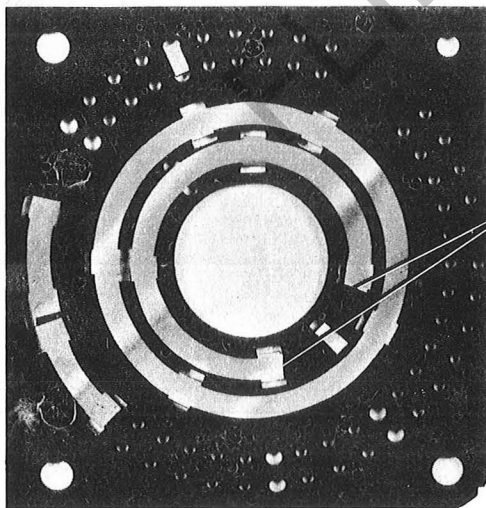
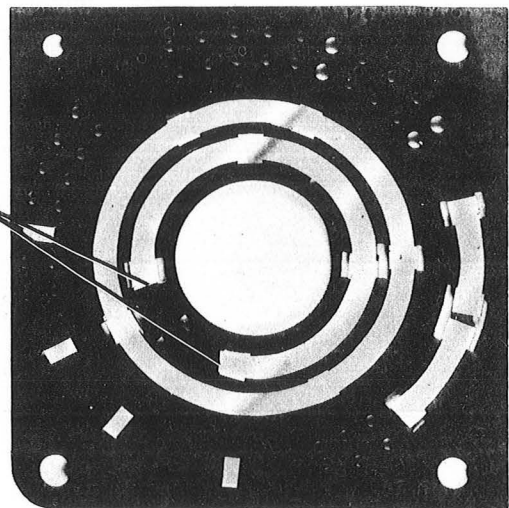
Figure 2.

- CAUSE:** Full Cycle Patch (Contact Ring) on Cancel and/or Motor Contact Plate and Wire Assembly not correctly trimmed.
- CORRECTION:** Should the above complaint occur perform the following:

INCORRECTLY  
TRIMMED

6. Should Full Cycle Patches be incorrectly trimmed, as shown in Figure 2, trim ends of Full Cycle Patches squarely with a sharp knife.
  7. Verify that no burrs remain after trimming.
