WURLITZER SERVICE SLANT

Fluorescent lamp wiring on all Model 3600, 3660 and 3610 Phonographs shipped from the factory prior to the following serial numbers:

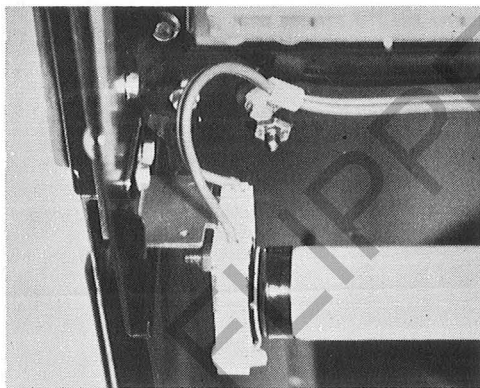
Figure 1. Upper Door Assembly - Left Hand

Fluorescent lamp wires being pinched by cable clamps causing separation of insulation.

Inspect the areas shown in Figures 1 through 4 and verify that wires are not pinched by CABLE CLAMPS. If wires are pinched, perform the following:

- Loosen CABLE CLAMPS shown in Figures 1 through 4 and inspect insulation.
- If insulation is broken or separated, tape with plastic electrical tape and reinstall CABLE CLAMP making sure that wire is properly positioned in CABLE CLAMP to prevent pinching.
