Change in design of program change key stop, #49299, Encore Program Selector. The above mentioned part is pictured on page 30 of the Parts Section of the Service Handbook for Model 1100 Wurlitzer Phonograph.

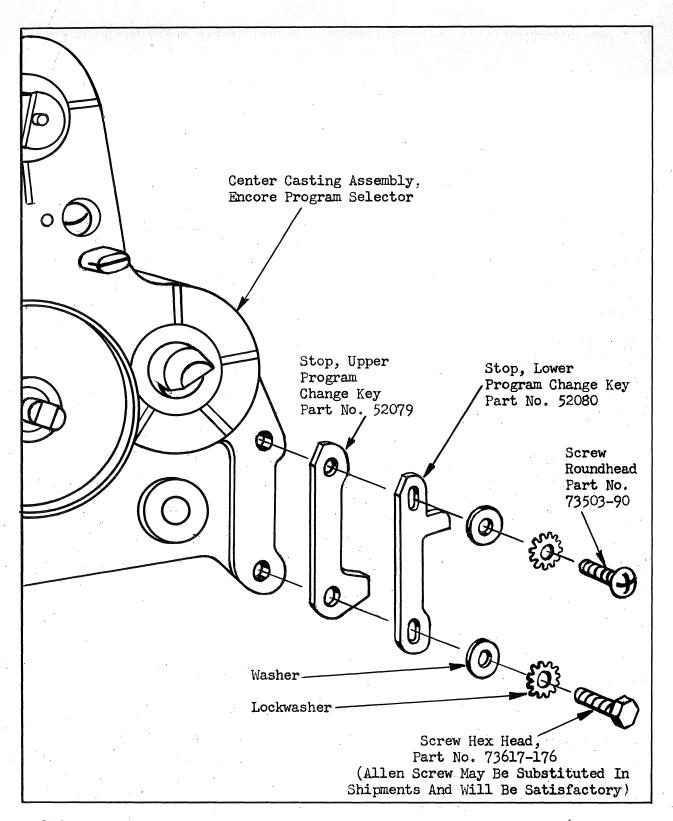
Drawing on reverse of page shows method of installation of the new stops. Only those parts on which the part numbers are shown are supplied; other parts shown are those which are already in the assembly as originally constructed. New screws specified are 1/16 inch longer and should be used in place of the old ones.

This stop has been redesigned and is now made up of two pieces instead of one. One piece, part number 52079, is L shaped and has mounting holes which are not elongated, the leg of the L forming the lower stop for the travel of the program change button. No adjustment is required at the bottom of the program change key travel, since this is covered through adjustment of the program change key extension lever.

The other piece, part number 52080, has elongated mounting holes and a side arm which forms the upper stop for the travel of the program change button. It is possible to position this stop so that the program change key maintains its correct "at rest" position. When in this position, the key is aligned with the selector keys and its upper edge does not rest against the lip of the front trim casting.

After removing the Encore Program Selector from the front door of the phonograph, access to the upper (round head) screw can be obtained, with a screwdriver of suitable length, through the opening made available by removing the L. H. number roller assembly. The lower (hex head or Allen)screw can be removed with a suitable wrench.
